Manhole Inspection Summary

Manhole # S43I2_001MH

Insp Date: **11/27/08 11:30 AM**

Location Address: **1219 Church St.**

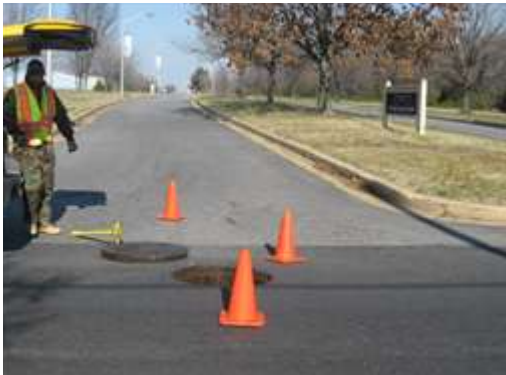
Location View

1219 Church St.

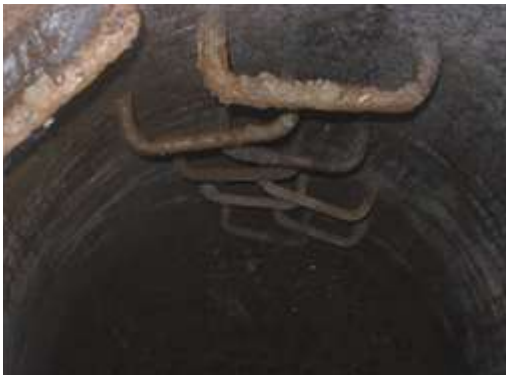
Steps Count: **9** Missing: **0** ☒ **Corroded**

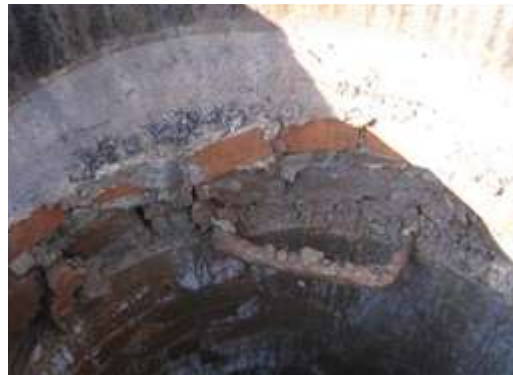
Defect 1

Condition: ☐ Sound ☒ **Cracked** ☐ Root Intrusion ☐ Loose Brick ☐ Deteriorated

Infiltration: ☐ None ☒ **Joint** ☐ Cracks ☐ Mortar ☐ Roots ☐ Wall

Cracked Chimney

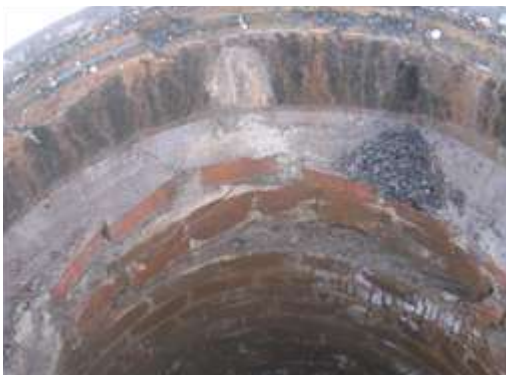
Defect 2

Deteriorated Frame-Chimney Joint

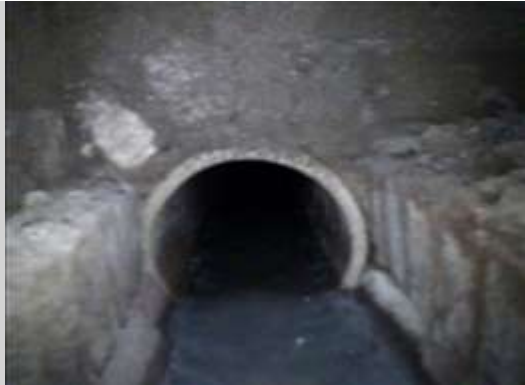
12 O'Clock Outflow

8 in. Circular Gravity Sewer
Pipe Out @ 12 O'Clock

Pipe Height: **8.4** (in.) Rod and Bar (Angled)
Pipe Material: **Clay** ☐ Pipe Lined
Invert Depth: **14.42** (ft.) Flow Characteristics: **Fast**
Deposits: ☒ None ☐ Mud ☐ Sludge ☐ Debris ☐ Grease
Silt Depth: (in.) Deposits Extent:
Infiltration: **None** Pipe Seal Cond: **Sound**

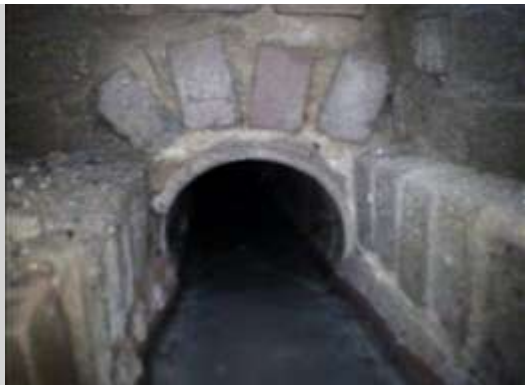
6 O'Clock Inflow

8 in. Circular Gravity Sewer
Pipe In @ 6 O'Clock

Pipe Height: **8.4** (in.) Rod and Bar (Angled)
Pipe Material: **Clay** ☐ Pipe Lined
Invert Depth: **14.30** (ft.) Flow Characteristics: **Fast**
Deposits: ☒ None ☐ Mud ☐ Sludge ☐ Debris ☐ Grease
Silt Depth: (in.) Deposits Extent:
Infiltration: **None** Pipe Seal Cond: **Sound**
